**A CHARACTERIZATION AND ANALYSIS
OF THE FLOOR PLASTERS
FROM THE ACROPOLIS AT COPAN, HONDURAS**

A THESIS

**The Graduate Program in Historic Preservation in
Partial Fulfillment of the Requirements for the Degree of the Master of Science**

1998

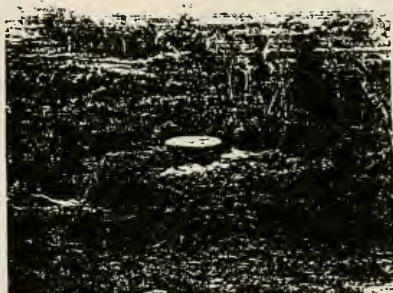
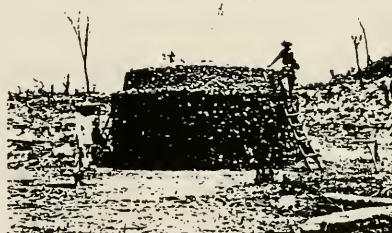
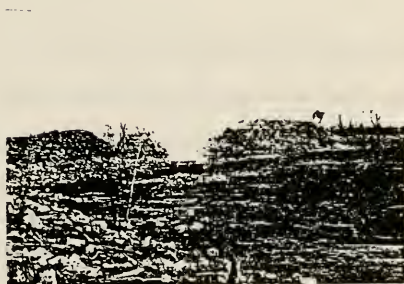
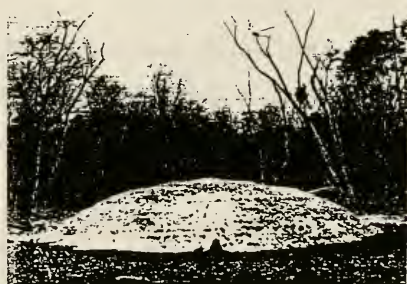
Figure 4. Yucatecan Method for Lime Burning. From Earl Morris, *Temple of the Warriors at Chichen Itza*, (Washington, D.C.: Carnegie Institute of Washington, 1931), 221.

FIG. 134—COMPLETED CYLINDER OF WOOD FOR
LIME BURNING

FIG. 135—CYLINDER OF WOOD SURMOUNTED BY
BROKEN STONE, READY FOR FIRING

FIG. 136—LIME HEAP BURNING

FIG. 137—LIME HEAP AFTER BURNING

Archaeological studies suggest the ancient Yucatan method of producing lime was implemented at Copan, as recounted by Earl Morris during his work the Temple of the Warriors at Chichen Itza.⁴⁹ (Figure 4) The process commenced with the erection of a *calera* consisting of a 2 meter high cylindrical pile of freshly cut timber radiating around a center pole. A layer of quarried limestone chunks, measuring 0.5 - 0.75 meters thick, were placed on the wooden pyre. With the center pole removed, the base was ignited to calcine the limestone, transforming it into a fine white powder within 24-30 hours. The exposure to moisture from dew and rain slaked the powder, causing it to expand approximately 5-6 times its original volume.⁵⁰ To obtain the highest quality plaster, the lime was stored for periods up to a year to ensure sufficient hydration.

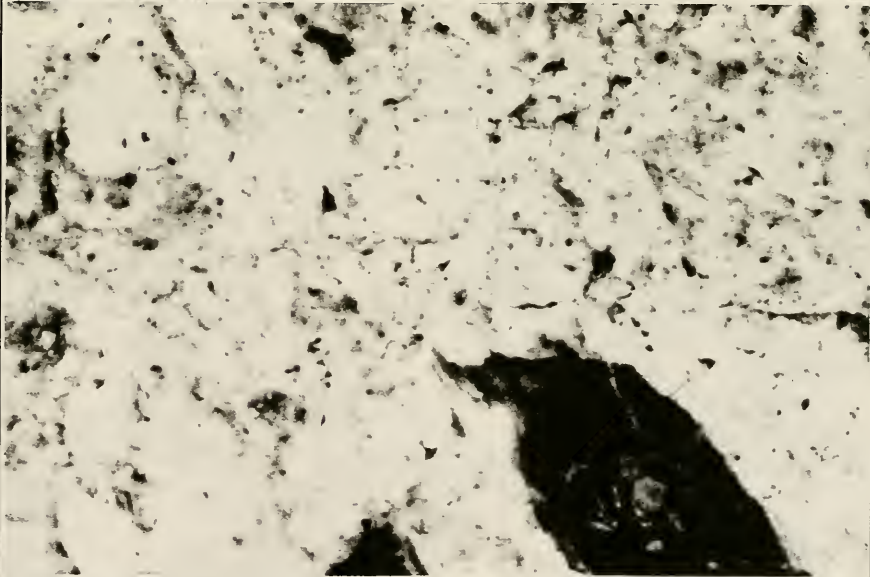
CROSS SECTION EXAMINATION		SAMPLE: 27
Floor Name: Mot Mot		
Sample Location: Northeast Court Group, north of Tartan.		
Division: 5, MAS 7	Date: A.D. 460 - 470	Magnification: 5x
<p>General Description:</p> <p>Sample consists of a heterogeneous tan-colored matrix. White and cream colored aggregates, ranging from fine to coarse sizes up to 0.2 mm are distributed throughout. They are poorly sorted and of rounded and subrounded shapes. The types of calcite-based constituents are difficult to discern due to their varying colors and textures. Several fine black particles, likely representing carbon are contained within the matrix and the calcite-based particles. A few fine-sized rust colored particles are visible. No distinct layers are discernible.</p>

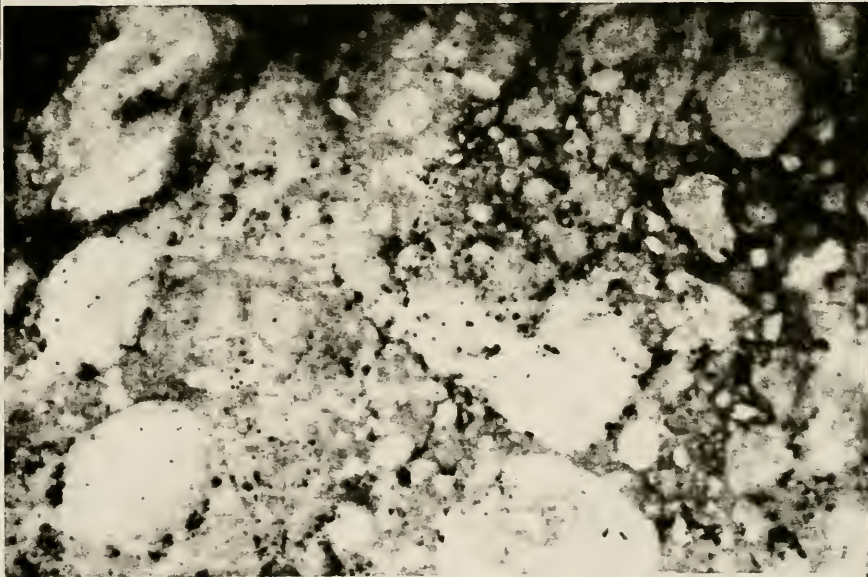
CROSS SECTION EXAMINATION		SAMPLE: 28
Floor Name: Division 4 Court 4C Floor (Sharer)		
Sample Location: Northeast Court Group, south of Heron.		
Division: 4	Date: A.D. 480 - 520	Magnification: 5x
<p>General Description:</p> <p>Sample consists of a tan and ivory-colored homogeneous plaster matrix comprising an agglomeration of spherical, calcite-based particles with indistinct boundaries. The medium size spherical particles vary in color (white, tan, ivory, and gray.) There are a few brown and rust colored particles, ranging in size from fine to medium, of subangular and subangular shapes. Large cracks penetrate one end of the sample and smaller ones occur at the opposite end. Small voids are scattered throughout, possibly occupied once by fine-sized aggregates. No distinct layers are discernible.</p>

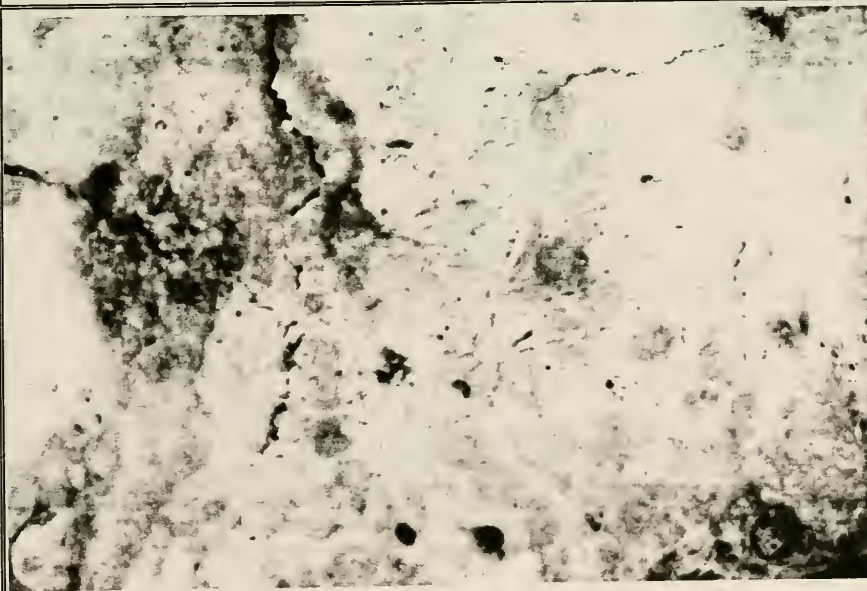
CROSS SECTION EXAMINATION		SAMPLE: 34
Floor Name: Gordon Floor		
Sample Location: Northeast Court Group, north of Toucan.		
Division: 4	Date: A.D. 480 - 520	Magnification: 7.5x
<p>General Description:</p> <p>Sample consists of a compact, homogeneous, cream and yellow-colored plaster matrix. It is fairly uniform in texture, except for a few spherical and oblong-shaped voids, measuring approximately 0.2 mm which appear to have been occupied by aggregate particles and/or air bubbles. A few calcite-based constituents and fine rust particles are present, although the latter are barely visible within the matrix. No distinct layers are discernible.</p>

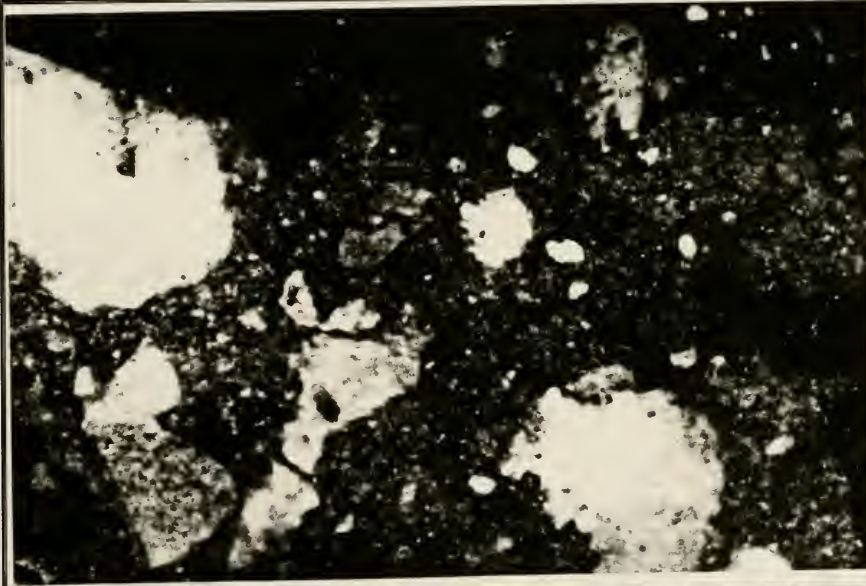
CROSS SECTION EXAMINATION		SAMPLE: 38
Floor Name: Loro		
Sample Location: Northeast Court Group, 2 meters within south central door.		
Division: 4	Date: A.D. 480 - 520	Magnification: 5x
<p>General Description:</p> <p>Sample consists of a heterogeneous cream-colored plaster matrix including an agglomeration of subrounded particles. Subangular and subrounded aggregates of various colors (green, rust, gray, and brown) ranging from fine to coarse sizes, up to 0.3 mm are distributed throughout. Medium to coarse-sized calcite based particles of spherical and oblong shapes are visible.</p> <p>The finish layer, measuring 0.1 mm, appears very dense and consists of fine particle inclusions. The brown matrix contains various colored aggregates (green, brown, and gray). A vertical crack penetrates the finish layer.</p>

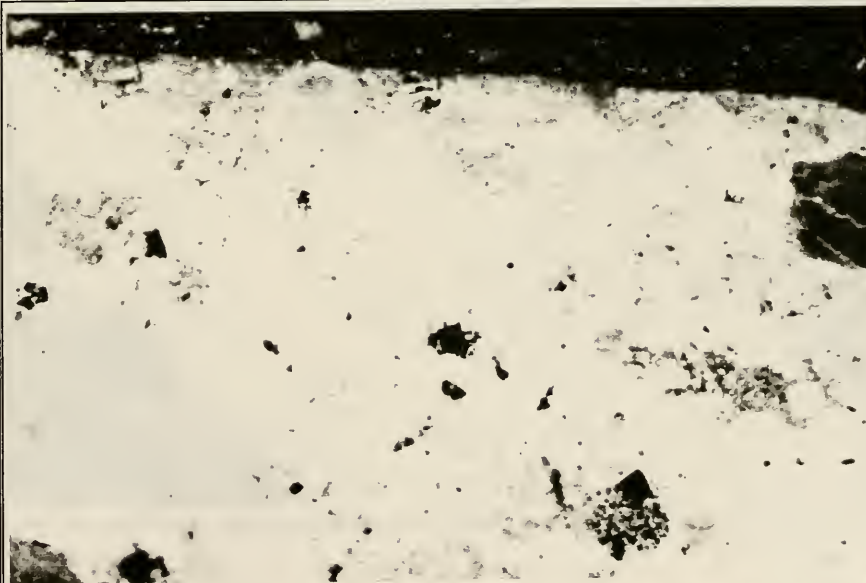
CROSS SECTION EXAMINATION		SAMPLE: 40
Floor Name: Ganso Interior		
Sample Location: Northeast Court Group, north room.		
Division: 2	Date: A.D. 540 - 650	Magnification: 5x
<p>General Description:</p> <p>Sample consists of a homogeneous plaster matrix of varying shades of white and cream. Spherically-shaped voids are present within the matrix where particles may have once occupied. A few dark gray and brown particles of fine to medium sizes and subangular shapes are visible. Trace amounts of black-colored particles are present, most likely indicating carbon from burnt fuel.</p> <p>The dense finish layer is rust colored, likely from iron oxides, and contains a greater proportion of fine sized particles, measuring approximately 0.15 mm.</p>

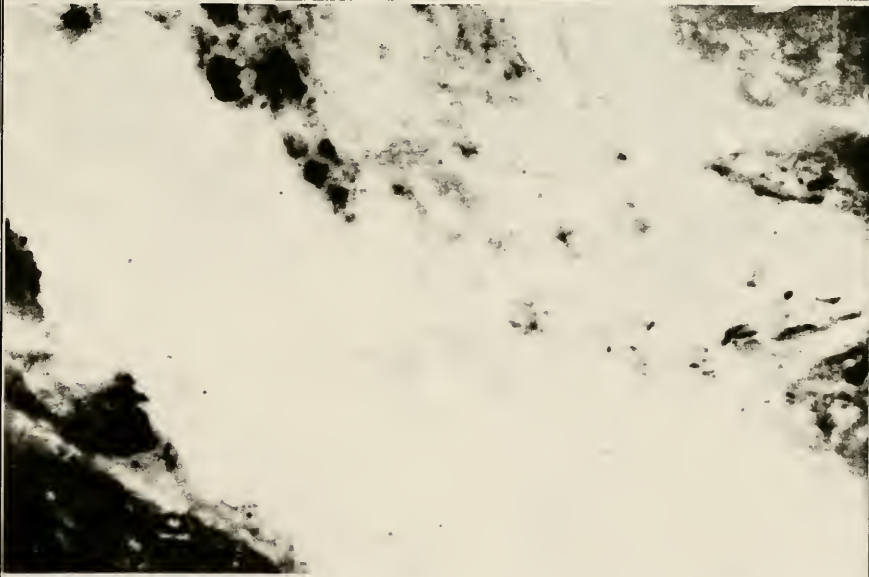
CROSS SECTION EXAMINATION		SAMPLE: 53
Floor Name: Division 2 Court		
Sample Location: Northeast Court Group, south of Chachalaca.		
Division: 2	Date: A.D. 540 - 650	Magnification: 5x
<p>General Description:</p> <p>Sample consists of a cream colored plaster matrix with a chaotic texture. Fine to coarse-sized particles, ranging from 0.1 to 0.15 mm, which vary in color from white to cream and appear to be much denser than the surrounding matrix, possibly indicating limestone aggregates. A partial crack runs parallel to the finish layer. Poorly sorted aggregates of various colors (orange, brown, pink, green, gray, and red), some semi-translucent, of angular, subangular and subrounded shapes.</p> <p>A rust-colored finish layer, measuring approximately 0.05 mm, is denser and contains well sorted fine-sized particles.</p>

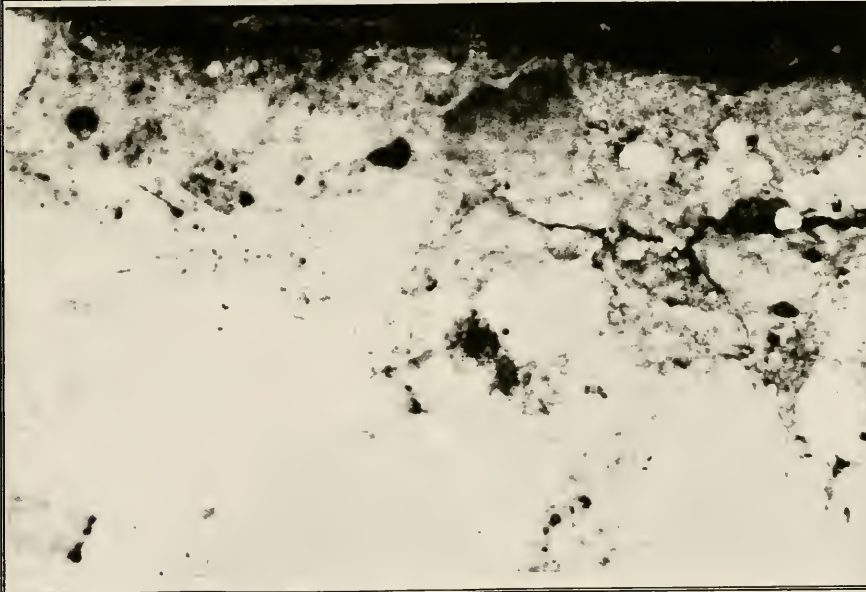
CROSS SECTION EXAMINATION		SAMPLE: 54
Floor Name: Chachalaca Interior		
Sample Location: South side, side of ripped out bench.		
Division: 2	Date: A.D. 540 - 650	Magnification: 6.25x
<p>General Description:</p> <p>Sample consists of a heterogeneous and compact tan-colored plaster matrix. (The variation in color is due to the resin penetrating the matrix.) Poorly sorted aggregates of various sizes and colors (brown, yellow, white, green, red) are present and subrounded, subangular, and angular shapes are present. Calcite-based particles in varying shades of white to cream indicate limestone fragments. No distinct layers are discernible.</p>

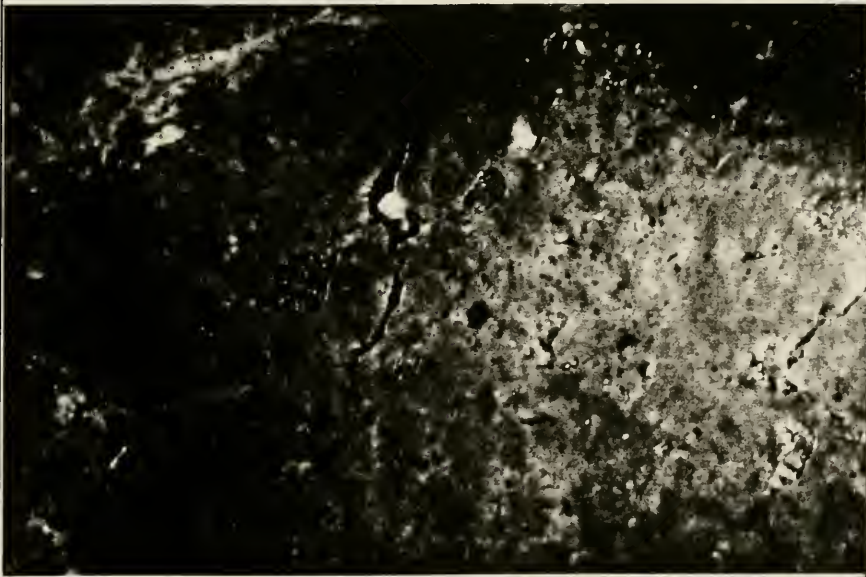
CROSS SECTION EXAMINATION		SAMPLE: 60
Floor Name: Chachalaca, Floor #2		
Sample Location: Northeast Court Group, penultimate plaza floor on east side.		
Division: 2	Date: A.D. 540 – 650	Magnification: 5x
<p>General Description:</p> <p>Sample consists of a compact, homogeneous matrix with varying shades of cream and white. Within the ground layer, there are striations, but no distinct layers or aggregates. Rust stains are present throughout the matrix.</p> <p>The finish layer, measuring approximately 0.2 mm, is cream-colored with some fine particles visible. It is difficult to discern shapes and sorting since their edges are not distinguishable.</p>

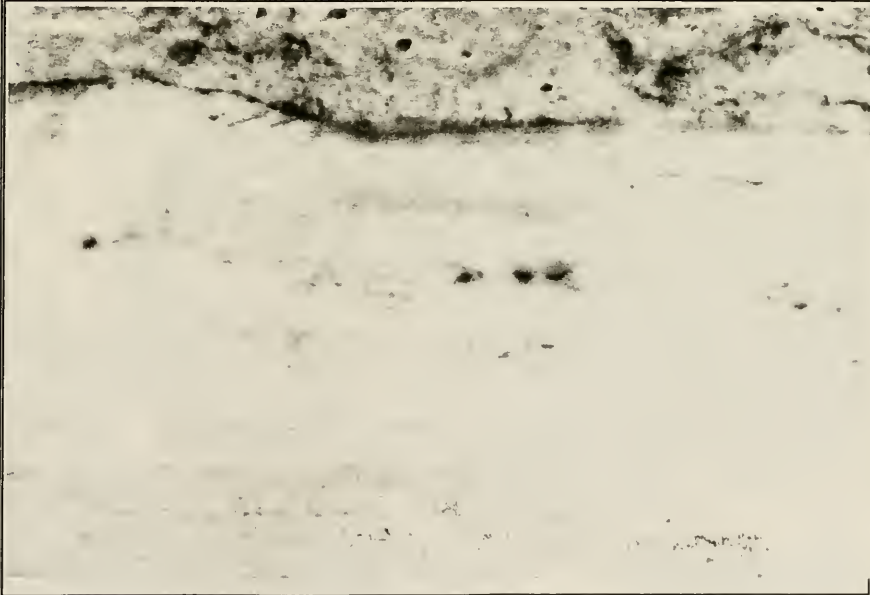
CROSS SECTION EXAMINATION		SAMPLE: 61
Floor Name: Chachalaca, Floor #3		
Sample Location: Northeast Court Group, 3 rd Plaza surface above top of Indigo.		
Division: 2	Date: A.D. 540 – 650	Magnification: 5x
<p>General Description:</p> <p>Sample consists of a heterogeneous plaster matrix which is relatively compact, containing particles of a white and cream colors in various sizes. The sample is dominated by a large green tuff aggregate, measuring approximately 0.8 mm, surrounded by smaller tuff particles and various colored aggregates (brown and rust) of subangular and subrounded shapes. A crack runs the width of the coarse aggregate which appears to be partially filled in with calcareous material. There are some black regions, possibly indicating carbon. No layers are discernible.</p>

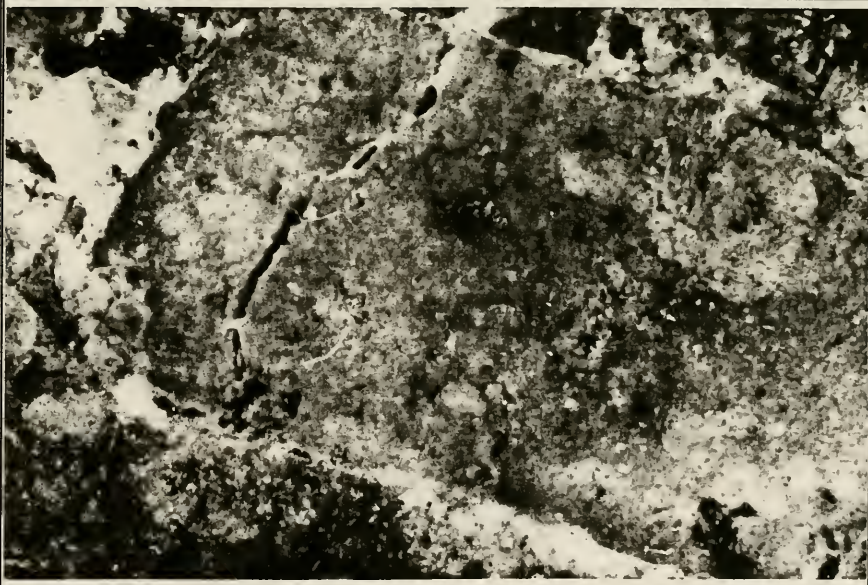
CROSS SECTION EXAMINATION		SAMPLE: 62
Floor Name: Chachalaca, Floor #4		
Sample Location: Northeast Court Group, 2 nd Plaza Surface above top of Indigo.		
Division: 2	Date: A.D. 540 – 650	Magnification: 7.5x
<p>General Description:</p> <p>Sample is dominated by a gray coarse-sized aggregate, measuring 1.3 mm, and containing white veins throughout. The surrounding chaotic plaster matrix is compact and has an orange cast, most likely the result of iron staining. Within the matrix, fine aggregate particles varying in color (orange, brown, and red) and of subangular shapes are present. No layers are discernible.</p>

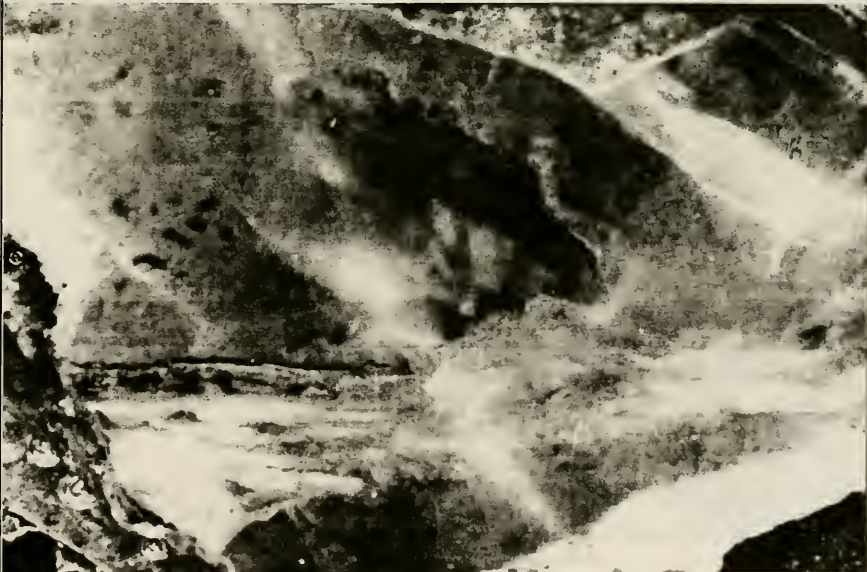
CROSS SECTION EXAMINATION		SAMPLE: 63
Floor Name: Chachalaca, Floor #5.		
Sample Location: Northeast Court Group, 1 st Plaza surface above top of Indigo.		
Division: 2	Date: A.D. 540 – 650..	Magnification: 5x
<p>General Description:</p> <p>Sample consists of a chaotic and compact plaster matrix. Within the tan-colored matrix are poorly sorted aggregates of various colors (gray, tan, orange, yellow, green, rust, pink, cream, and white) and are subangular, rounded and subrounded shapes. A shell fragment is visible on the surface. The white and tan particles, possibly indicating limestone aggregates, measuring approximately 0.1 mm, are both opaque and translucent.</p> <p>The finish layer, measuring approximately 0.1 mm, is a dark brown and denser than the ground layer. The fine particles are well sorted and subangular and subrounded in shape.</p>

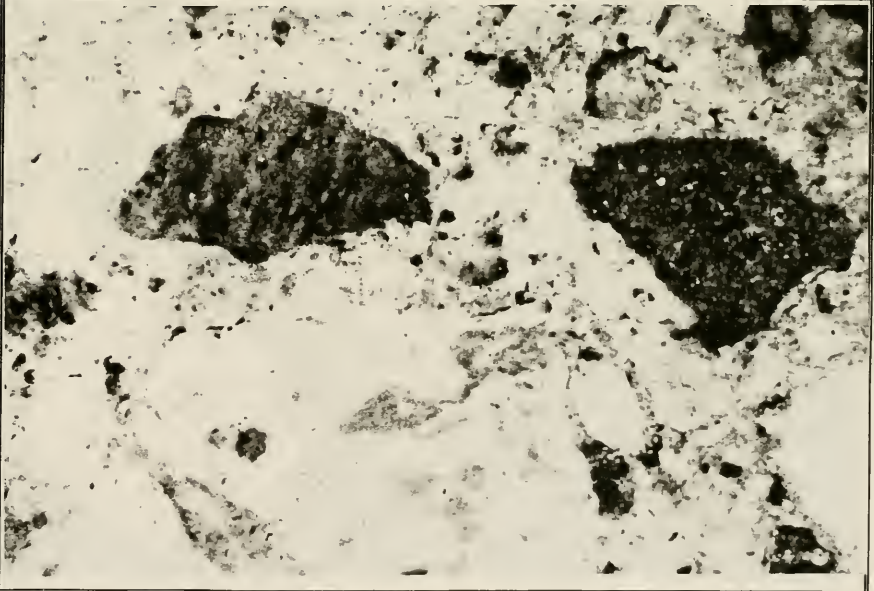
CROSS SECTION EXAMINATION		SAMPLE: 67
Floor Name: Indigo		
Sample Location: Northeast Court Group, floor upon which Indigo rests.		
Division: 2	Date: A.D. 540 – 650	Magnification: 7.5x
<p>General Description:</p> <p>Sample consists of a porous brown-colored chaotic matrix containing poorly sorted aggregates of various colors (green, brown, rust, yellow, pink, and white) of subrounded and subangular shapes. The matrix is dominated by a coarse-sized green tuff aggregate, measuring 1.2 mm, containing various colored minerals. The next largest aggregate is a white medium-sized aggregate, measuring 0.4 mm, and most likely a limestone fragment. A large strip of black, 0.6 mm in length, most likely representing carbon, separates the two aggregates within the matrix. No distinct layers are discernible.</p>

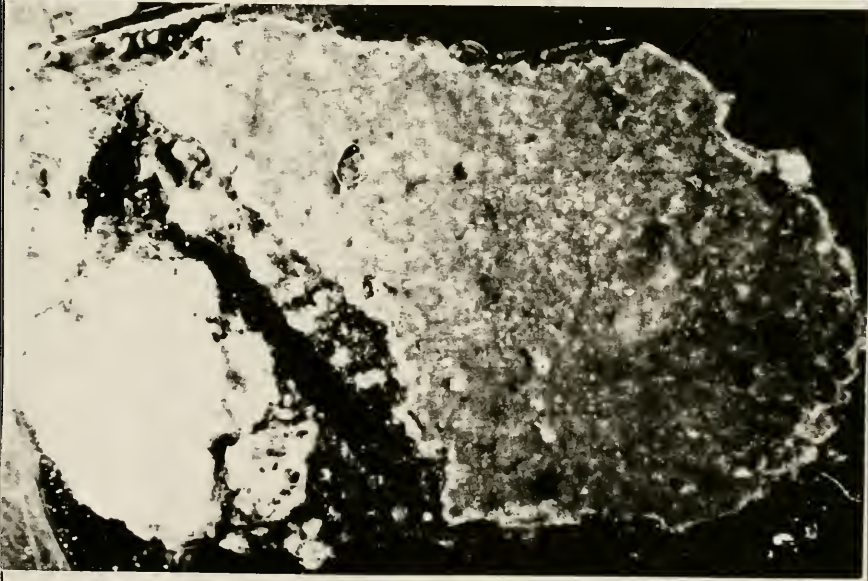
CROSS SECTION EXAMINATION		SAMPLE: 70
Floor Name: 22 Chiquito		
Sample Location: Northeast Court Group, atop highest terrace, north side.		
Division: 2	Date: A.D. 540 – 650	Magnification: 7.5x
<p>General Description:</p> <p>Sample consists of a chaotic tan-colored plaster matrix. Varying shades of white and cream colored particles in fine to coarse sizes are present, likely indicating limestone aggregates. The colored aggregates (brown, rust, pink, yellow, gray and green) vary in size from fine to coarse and are of subangular and subrounded shapes. Fine-sized black particles are visible, likely indicating carbon. No layers are discernible.</p>

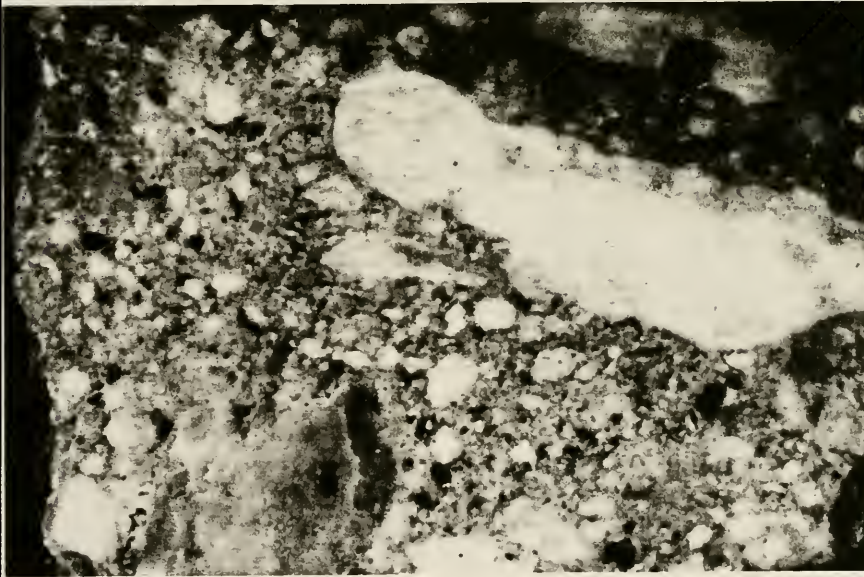
CROSS SECTION EXAMINATION		SAMPLE: 71
Floor Name: 22 Chiquito		
Sample Location: Northeast Court Group. 1 st Floor burying top of Chiquito.		
Division: 2	Date: A.D. 540 – 650	Magnification: 5x
General Description: Sample consists of a tannish-pink colored plaster matrix with a chaotic texture of calcite-based constituents, such as limestone aggregates in various sizes distinguishable from the surrounding matrix. Varying shades of white and cream are exhibited in the particles and matrix. Rust and orange-colored particles in fine to coarse sizes are also present. The particle shapes are subangular and subrounded. It is moderately compact with voids where particles may have occupied. There are no discernible layers.

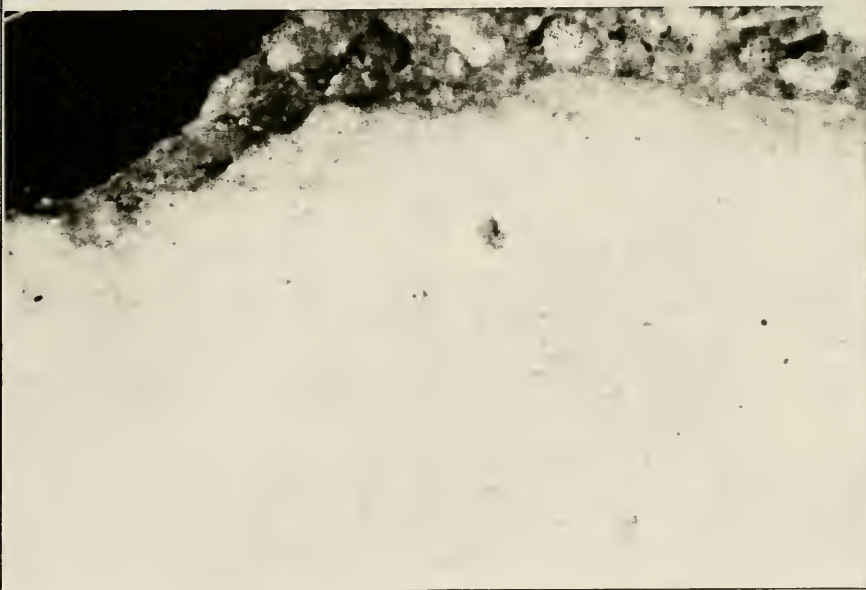
CROSS SECTION EXAMINATION		SAMPLE: 80
Floor Name: Division 5 Bernal		
Sample Location: MAS, at juncture with Chaj.		
Division: 5, MAS 7	Date: A.D. 460 470	Magnification: 5x
<p>General Description:</p> <p>Sample consists of a compact tan-colored homogeneous plaster matrix. Indistinct areas of varying shades of white and tan, indicating various calcite-based constituents. Voids are visible, measuring 0.05 mm, presumably occupied once by fine-sized particles. Moderately sorted aggregates of various colors (tan, brown, rust and gray), of subangular and rounded shapes are present. Fine black-colored particles may indicate the presence of carbon. No distinct layers are discernible.</p>

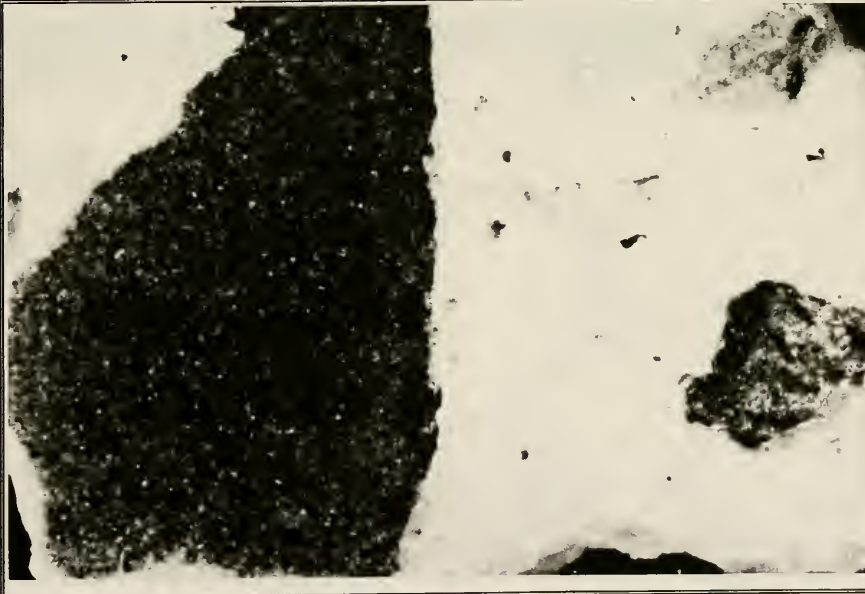
CROSS SECTION EXAMINATION		SAMPLE: 90
Floor Name: Banano		
Sample Location: MAS, west of Tuna.		
Division: 5, MAS 7	Date: A.D. 460 - 470.	Magnification: 10x
<p>General Description:</p> <p>Sample consists of a heterogeneous and compact, tan-colored matrix. Poorly sorted white and cream-colored aggregates ranging from fine to coarse sizes, of subangular and subrounded shapes, are distributed throughout the matrix. Some particles exhibit a solid color, and others varying shades, possibly indicating different types of calcite-based constituents. A few fine-sized rust-colored particles are visible as well as black particles, likely representing carbon. No distinct layers are discernible.</p>

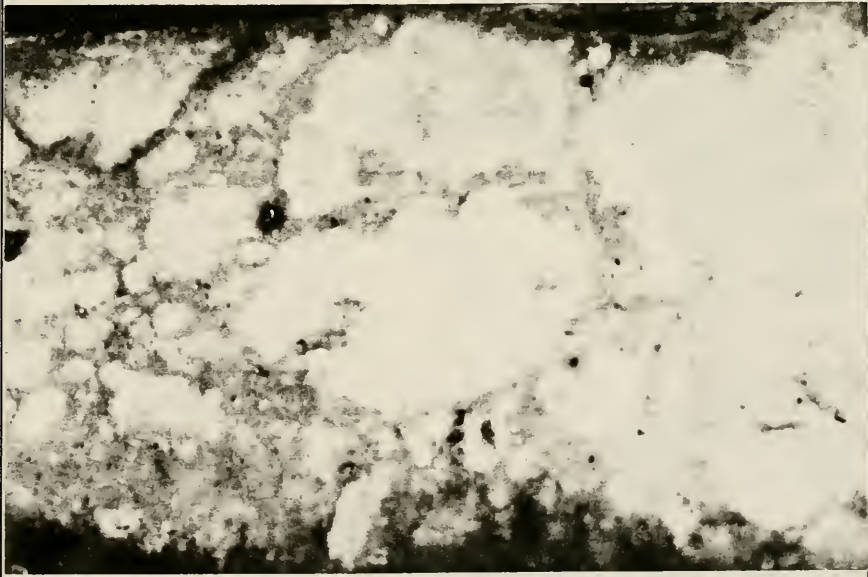
CROSS SECTION EXAMINATION		SAMPLE: 95
Floor Name: Asmen		
Sample Location: MAS, west of Margarita, under Tuna.		
Division: 5, MAS 9	Date: A.D. 440 - 450	Magnification: 5x
<p>General Description:</p> <p>Sample consists of a heterogeneous, tan-colored plaster matrix. Poorly sorted calcite-based aggregates, indicating limestone aggregates, measuring up to 0.1 mm, of rounded and subrounded shapes dominate the matrix. A large zone in the center of the matrix consists of a calcite-based particle. The encompassing matrix is darker in concentrated regions which may represent fine-sized brown particles and/or carbon material. No distinct layers are discernible.</p>

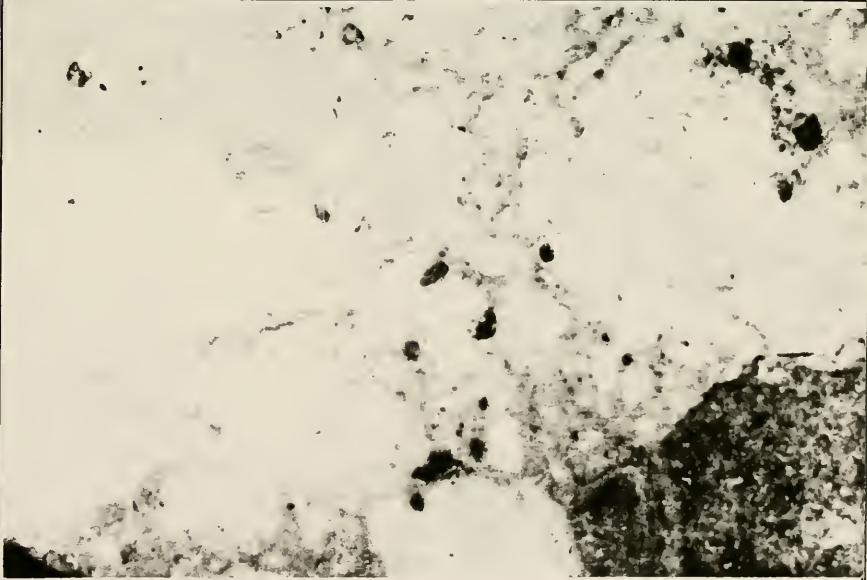
CROSS SECTION EXAMINATION		SAMPLE: 107
Floor Name: Ramirez		
Sample Location: MAS, integral with base of Papa.		
Division: 5, MAS 10	Date: A.D. 430 - 440	Magnification: 7.5x
<p>General Description:</p> <p>Sample consists of a heterogeneous, porous, and tan-colored plaster matrix. Several aggregates and zones of varying shades of white and cream are present, possibly indicating limestone aggregates. The calcareous regions are distinguished by different textures and degrees of compaction. They exhibit rounded, subrounded and subangular shapes. Fine to medium-sized aggregates, up to 0.2 mm, of subrounded and subangular shapes of various colors (brown, rust, and gray) are visible. No distinct layers are discernible.</p>

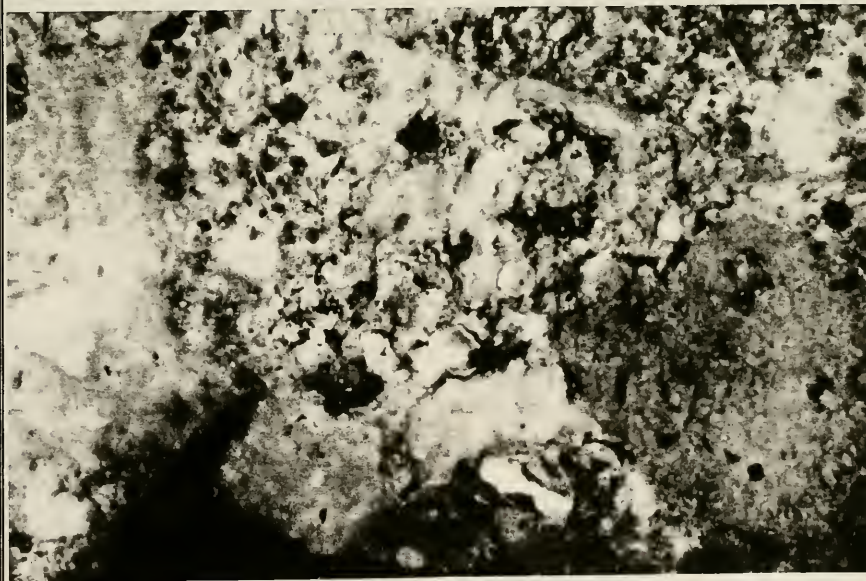
CROSS SECTION EXAMINATION		SAMPLE: 26701
Floor Name: Piso Don Marcos		
Sample Location: Rosalila, interior floor.		
Division: 2	Date: A.D. 540 - 650	Magnification: 5x
General Description: <p>Sample consists of a matrix in various shades of cream, white and tan. Heterogeneous in color and texture, it appears as an agglomeration of calcite-based particles, ranging from fine to coarse sizes up to 0.3 mm. Well sorted dark brown, rust, and green particles of subangular shapes punctuate the matrix. A rust-colored cast is concentrated in areas, likely from iron staining. No distinct layers are discernible.</p>

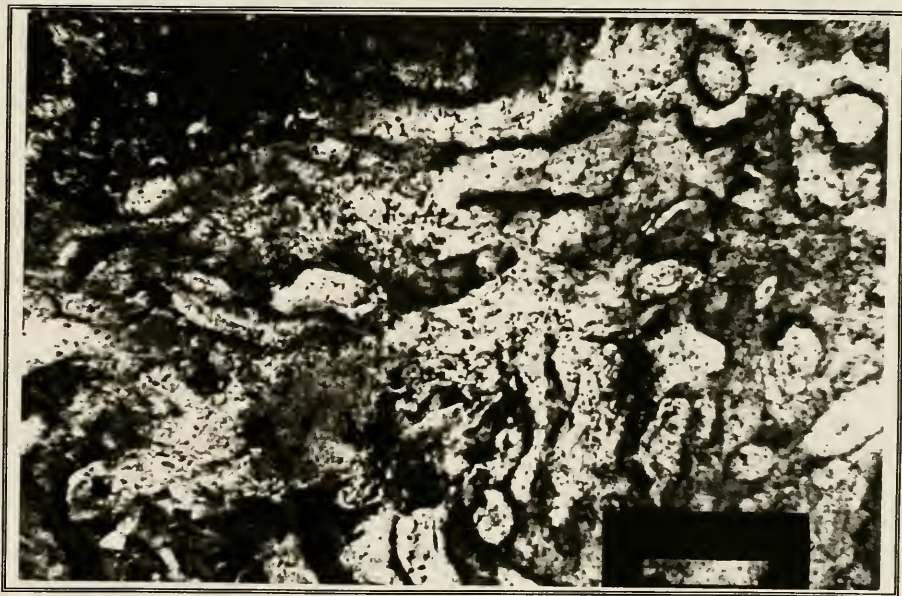
Photomicrograph of thin section #26 (Division 5) at 25x under transmitted light and crossed polars.

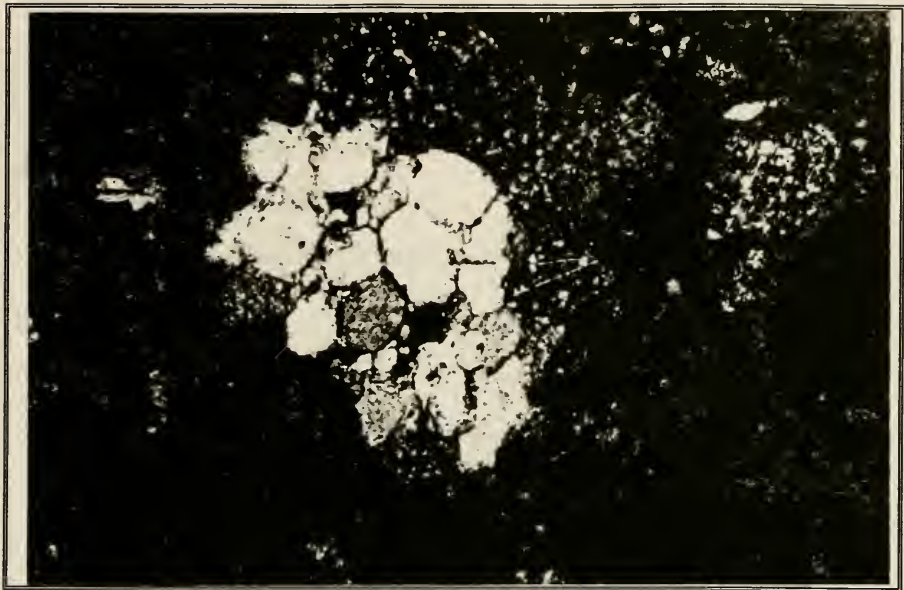
Photomicrograph of thin section #95 (Division 5) at 100x under transmitted light and crossed polars.

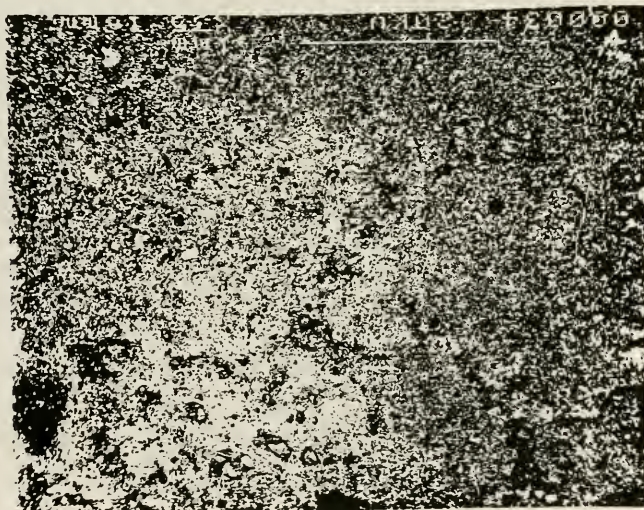
SAMPLE #95 (DIVISION 5)

X-RAY: 0 - 20 keV Window : None
 Live: 100s Preset: 100s Remaining: 0s
 Real: 195s 49% Dead

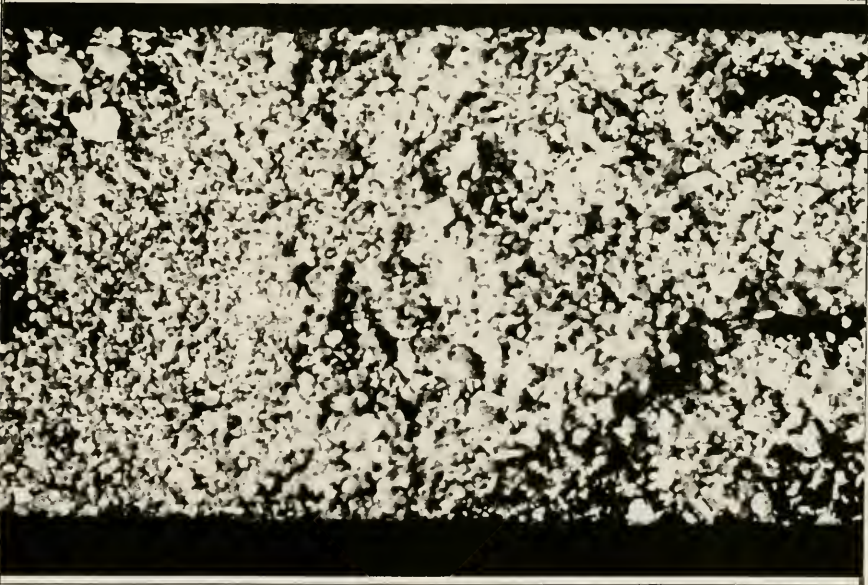
COARSE FRACTION EXAMINATION		SAMPLE #:28	
Floor Name: Division 4 Court 4C (Sharer)			
Sample Location: Northeast Court Group, south of Heron.			
Division: 4	Date: A.D. 480 - 520	Magnification: 10 x	
Shapes: Subround, and subangular.			
Colors: Rust, brown, green, pink, tan, white, and translucent.			
SIEVE ANALYSIS			
Sieve #	Size	Weight (grams)	% Retained
8	2.36 mm	0.02	12.5
16	1.18 mm	0	0
30	600 μ m	0.04	25
50	300 μ m	0.02	12.5
100	150 μ m	0.02	12.5
200	75 μ m	0.04	25
Pan		0.02	12.5

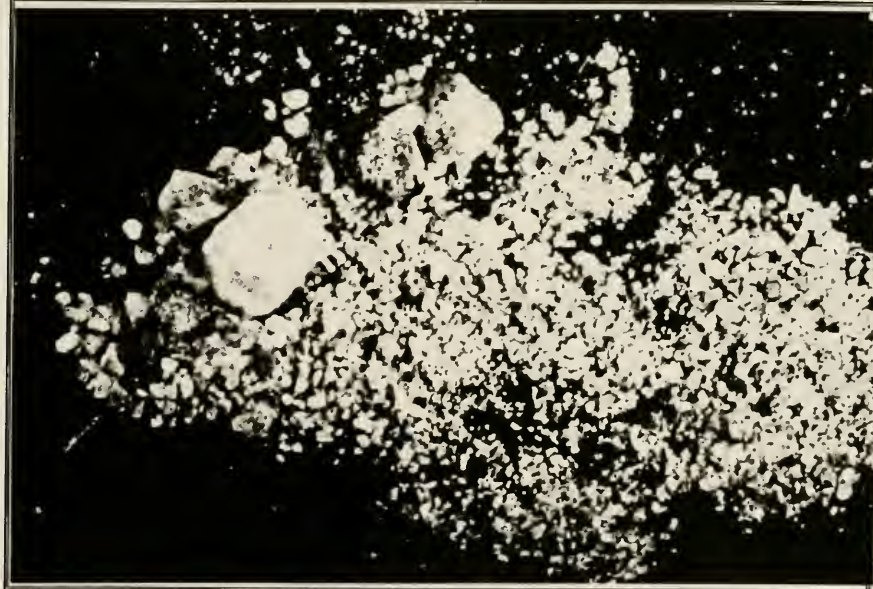
COARSE FRACTION EXAMINATION		SAMPLE #:35	
Floor Name: Toucan Interior			
Sample Location: Northeast Court Group, inside north central doorway.			
Division: 4	Date: A.D. 480 - 520	Magnification: 5x	
Shapes: Round, subround, and subangular.			
Colors: Gray, brown, orange, tan, and green.			
SIEVE ANALYSIS			
Sieve #	Size	Weight (grams)	% Retained
8	2.36 mm	0.26	20.31
16	1.18 mm	0.12	9.37
30	600 μm	0.14	10.93
50	300 μm	0.18	14.06
100	150 μm	0.26	20.31
200	75 μm	0.24	18.75
Pan		0.08	6.25

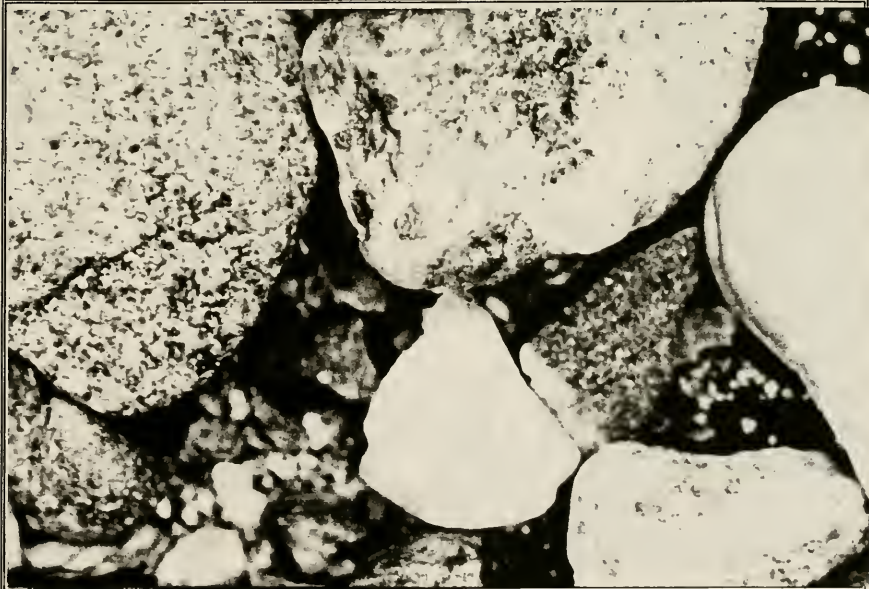
COARSE FRACTION EXAMINATION		SAMPLE #: 37	
Floor Name: Chinchilla			
Sample Location: Northeast Court Group, below Loro.			
Division: 6	Date: A.D. 250 - 420	Magnification: 5x	
Shapes: Round, subround, and subangular.			
Colors: Gray, green, tan, translucent, brown, orange, black, and white.			
SIEVE ANALYSIS			
Sieve #	Size	Weight (grams)	% Retained
8	2.36 mm	14.23	92.76
16	1.18 mm	0.19	1.24
30	600 μ m	0.07	0.46
50	300 μ m	0.11	0.72
100	150 μ m	0.35	2.28
200	75 μ m	0.32	2.09
Pan		0.07	0.46

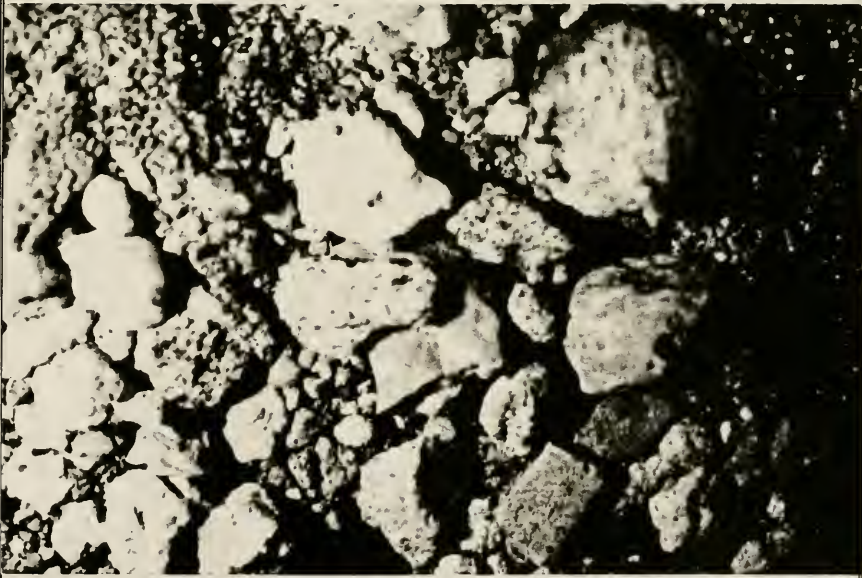
COARSE FRACTION EXAMINATION		SAMPLE #:38	
Floor Name: Loro Interior			
Sample Location: Northeast Court Group, 2 meters inside central doorway.			
Division: 5, MAS 11		Date: A.D. 460 - 470	Magnification: 5x
Shapes: Round, subround, and subangular.			
Colors: Gray, tan, brown, and orange.			
SIEVE ANALYSIS			
Sieve #	Size	Weight (grams)	% Retained
8	2.36 mm	1.09	76
16	1.18 mm	0.08	3.2
30	600 μm	0.08	3.2
50	300 μm	0.4	16
100	150 μm	0.04	1.6
200	75 μm	0	0
Pan		0	0

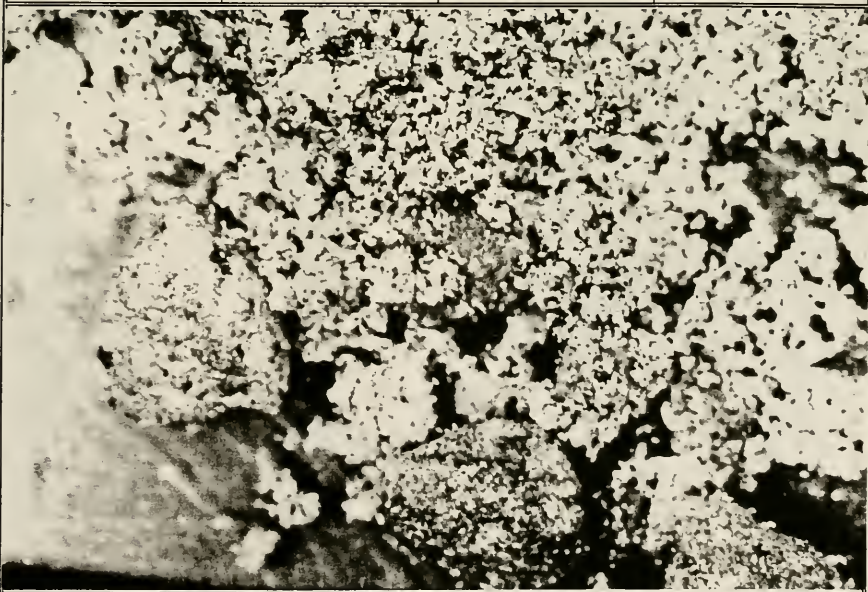
COARSE FRACTION EXAMINATION		SAMPLE #: 53	
Floor Name: Division 2 Court			
Sample Location: Northeast Court Group, court floor south of Chachalaca			
Division: 2	Date: A.D. 540 - 650	Magnification: 5x	
Shapes: Round, subround, and subangular.			
Colors: White, green, rust, brown, black, pink, gray, and orange.			
SIEVE ANALYSIS			
Sieve #	Size	Weight (grams)	% Retained
8	2.36 mm	1.86	18.62
16	1.18 mm	2.4	24.02
30	600 μm	1.56	15.65
50	300 μm	2.16	21.62
100	150 μm	1.65	16.65
200	75 μm	0.3	3.0
Pan		0.6	0.6

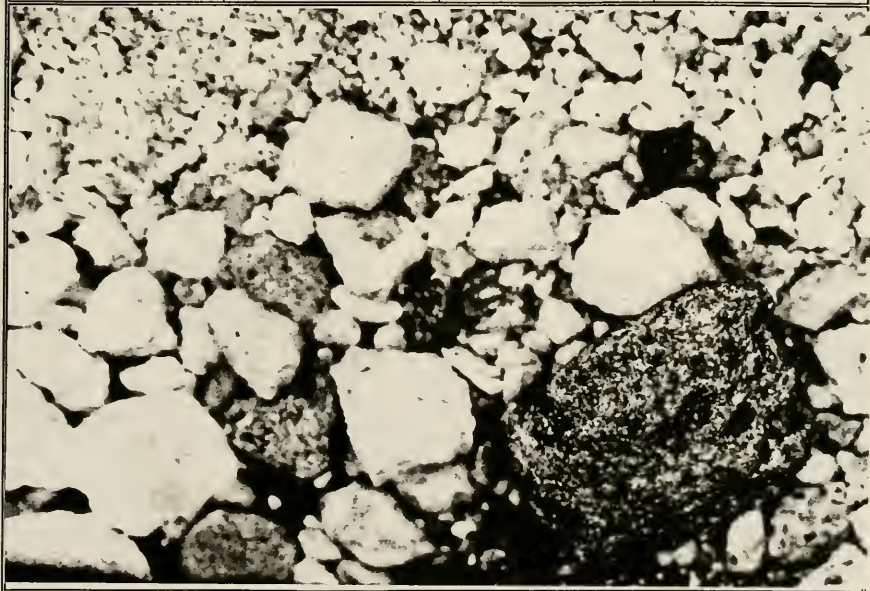
COARSE FRACTION EXAMINATION		SAMPLE #: 61	
Floor Name: Chachalaca Floor #3			
Sample Location: Northeast Court Group, 3 rd plaza surface above top of Indigo.			
Division: 2	Date: A.D. 540 - 650	Magnification: 3.75x	
Shapes: Subround, and subangular.			
Colors: Green, yellow, and black.			
SIEVE ANALYSIS			
Sieve #	Size	Weight (grams)	% Retained
8	2.36 mm	2.19	45.91
16	1.18 mm	0.84	17.61
30	600 μ m	0	0
50	300 μ m	0	0
100	150 μ m	1.42	29.56
200	75 μ m	0.27	5.66
Pan		0.06	1.25

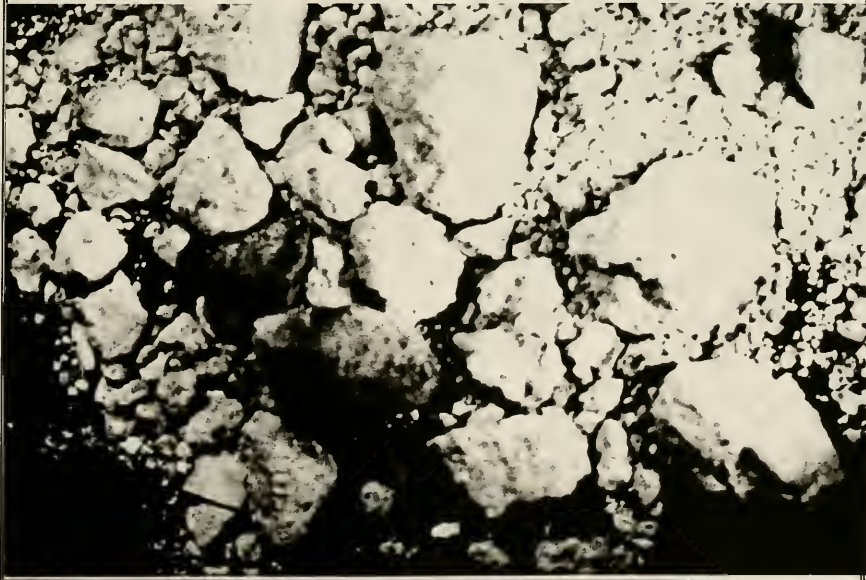
COARSE FRACTION EXAMINATION		SAMPLE #: 62	
Floor Name: Chachalaca Floor #4			
Sample Location: Northeast Court Group, 2nd plaza surface above top of Indigo.			
Division: 2		Date: A.D. 540 - 650	Magnification: 5x
Shapes: Subround, and subangular.			
Colors: Green, yellow, tan, rust, brown, gray, and pink.			
SIEVE ANALYSIS			
Sieve #	Size	Weight (grams)	% Retained
8	2.36 mm	0.16	6.25
16	1.18 mm	0.4	15.62
30	600 μm	0.28	10.94
50	300 μm	0.36	14.06
100	150 μm	0.56	21.87
200	75 μm	0.66	25.78
Pan		0.14	5.47

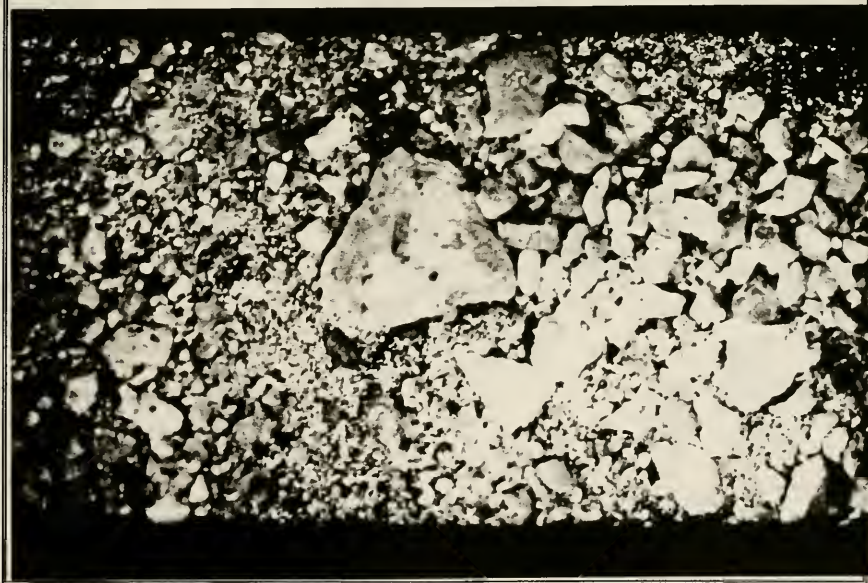
COARSE FRACTION EXAMINATION		SAMPLE #: 65	
Floor Name: Chachalaca Floor #7			
Sample Location: Northeast Court Group, abuts east side above last Div. 2 surface			
Division: 2		Date: A.D. 540 - 650	Magnification: 5x
Shapes: Round, subround, and subangular.			
Colors: Green, red, pink, and rust.			
SIEVE ANALYSIS			
Sieve #	Size	Weight (grams)	% Retained
8	2.36 mm	0.76	34.54
16	1.18 mm	0.35	15.91
30	600 μm	0.21	9.54
50	300 μm	0.29	13.18
100	150 μm	0.33	15.00
200	75 μm	0.22	10.00
Pan		0.04	1.82

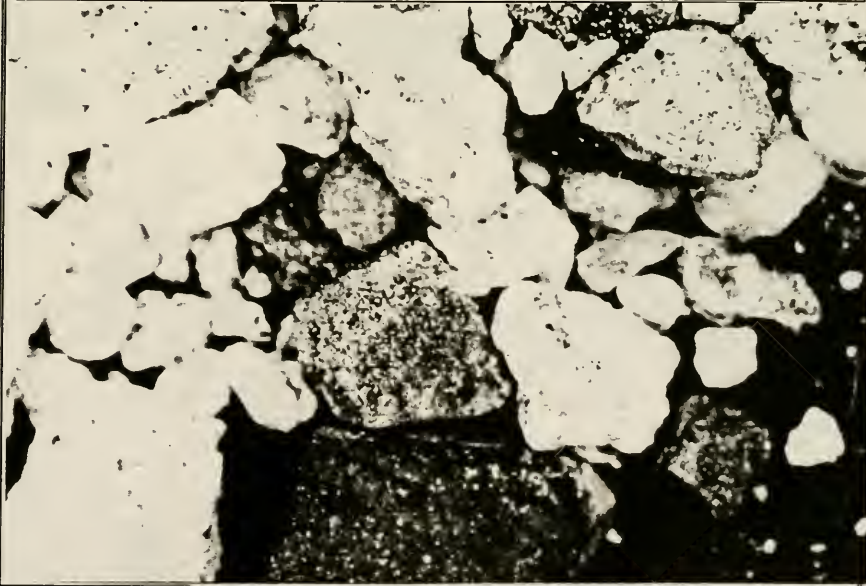
COARSE FRACTION EXAMINATION		SAMPLE #: 70	
Floor Name: 22 Chiquito			
Sample Location: Northeast Court Group. Floor atop highest terrace			
Division: 2		Date: A.D. 540 - 650	Magnification: 5x
Shapes: Subround and subangular.			
Colors: Brown, gray, green, rust on white, tan, and reddish-brown.			
SIEVE ANALYSIS			
Sieve #	Size	Weight (grams)	% Retained
8	2.36 mm	0.4	22.99
16	1.18 mm	0.48	27.59
30	600 μm	0.14	8.04
50	300 μm	0.26	14.94
100	150 μm	0.26	14.94
200	75 μm	0.16	9.20
Pan		0.04	2.30

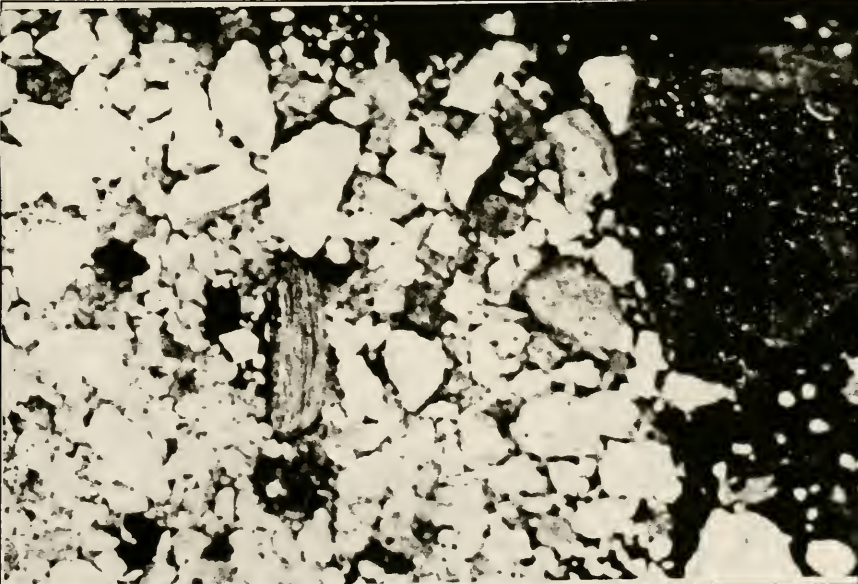
COARSE FRACTION EXAMINATION		SAMPLE #: 71	
Floor Name: 22 Chiquito			
Sample Location: Northeast Court Group. 1 st Floor (lowest) burying 22 Chiquito.			
Division: 2		Date: A.D. 540 - 650	Magnification: 7.5x
Shapes: Subround and subangular.			
Colors: Green, gray, white with rust, brown, and orange.			
SIEVE ANALYSIS			
Sieve #	Size	Weight (grams)	% Retained
8	2.36 mm	7.74	73.58
16	1.18 mm	1.50	16.37
30	600 μm	0.28	3.06
50	300 μm	0.26	2.84
100	150 μm	0.26	2.84
200	75 μm	0.12	1.31
Pan		0	0
